Allt a'Mharcaidh – River Restoration Design Vision Report

May 2021

Client: Cairngorms Connect / RSPB
Document number: 9441
Project number: 673614
Status: For Comment
Author: Glen Perez-Livermore / Martin Nichols
Reviewer: Dr Kenneth MacDougall
Date of issue: 27 May 2021
Filename: 9441_Allt a' Mharcaidh_Restoration Report_673614_200521_FOR_ISSUE

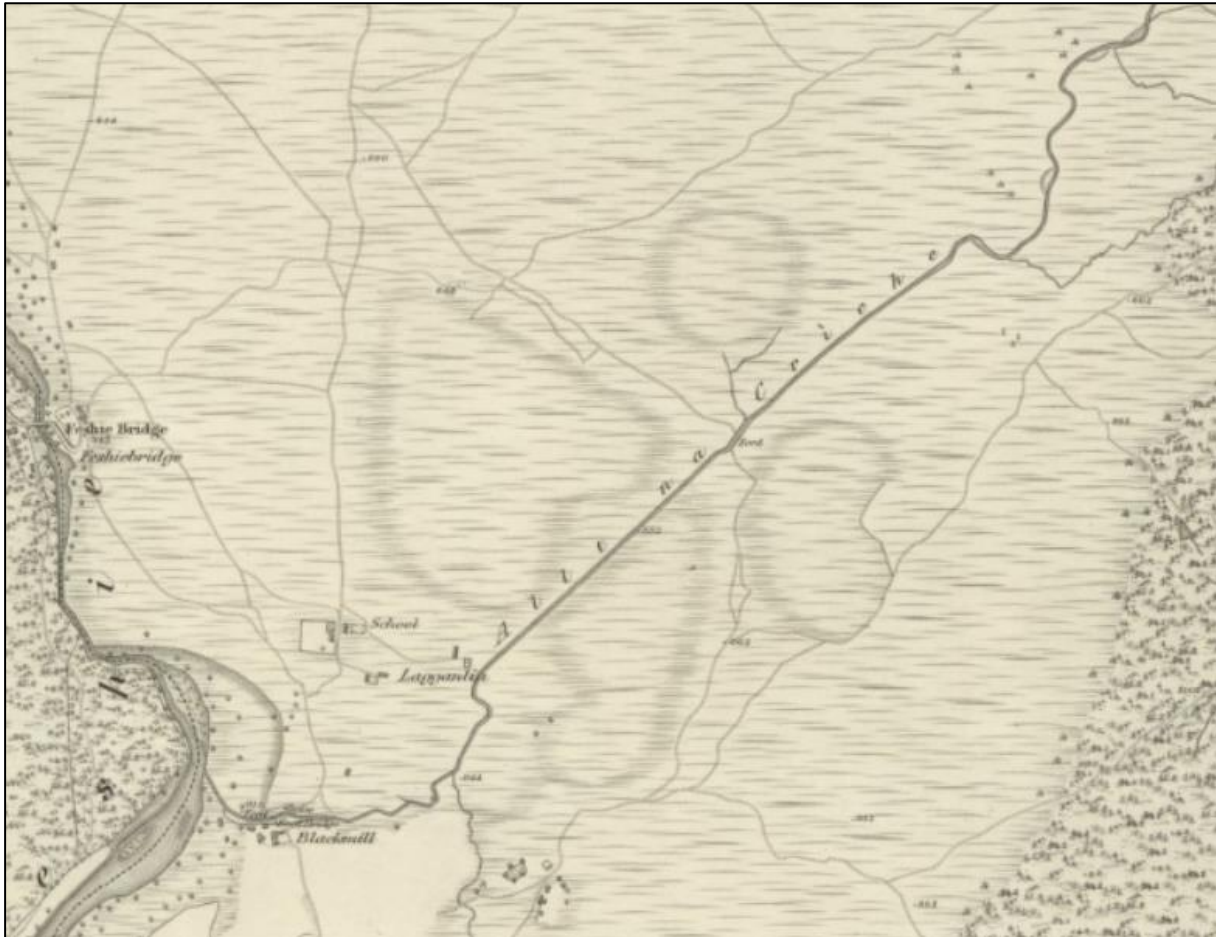
Figure 2-2: OS Six inch map showing the straightened study reach as surveyed in 1869

A review of historical mapping suggests that the majority of the study reach was straightened over 150 years ago. Figure 2-2 suggests that the reach has been straight since at least 1869.

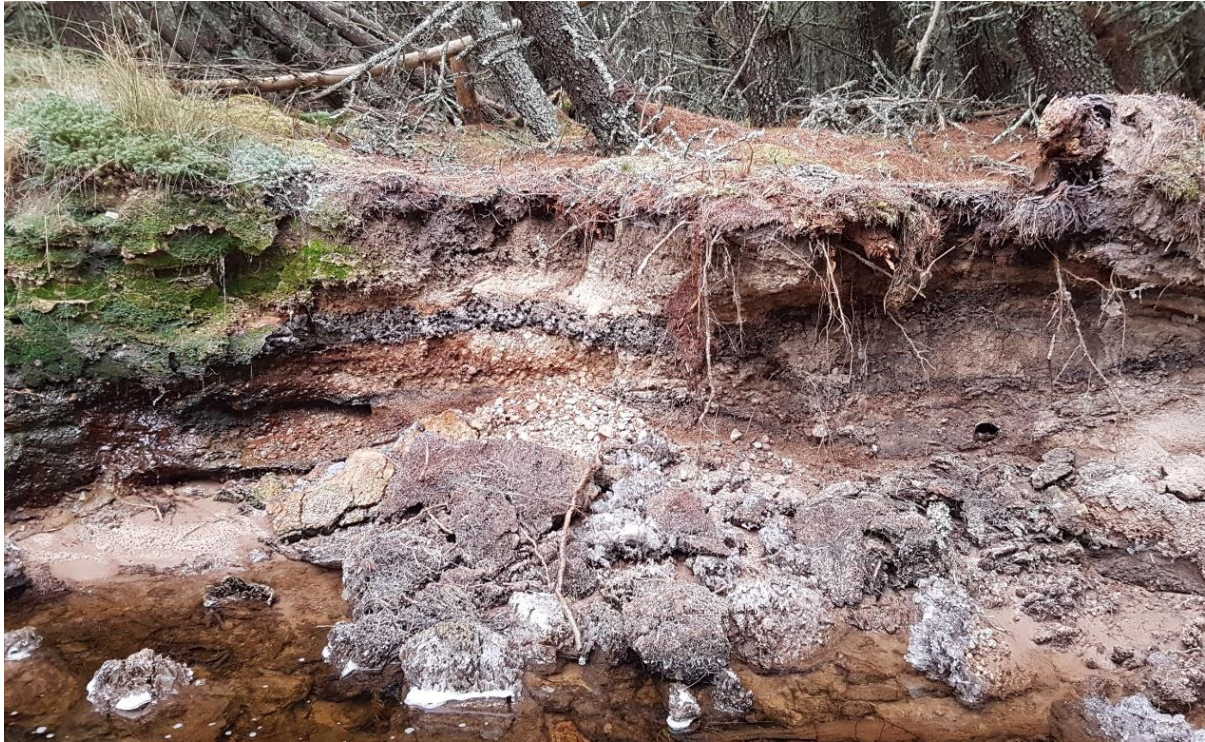
Photo 2-1: Photo showing stratification of the bank

Photo 2-1 shows an eroded bank towards the upstream section of the study reach, showing stratification of the alluvial deposits highlighting historic channel movement within the floodplain, and occurrence of historic flood events. Photo 2-2 shows the existing channel at the boundary between the upstream and central sections of the study reach, with a relic channel perched on the floodplain. The perched position of the relic channel sitting above the current bed level indicates that there has been channel incision in this area over time, likely due to headcut associated with the straightening and deepening of the channel downstream.

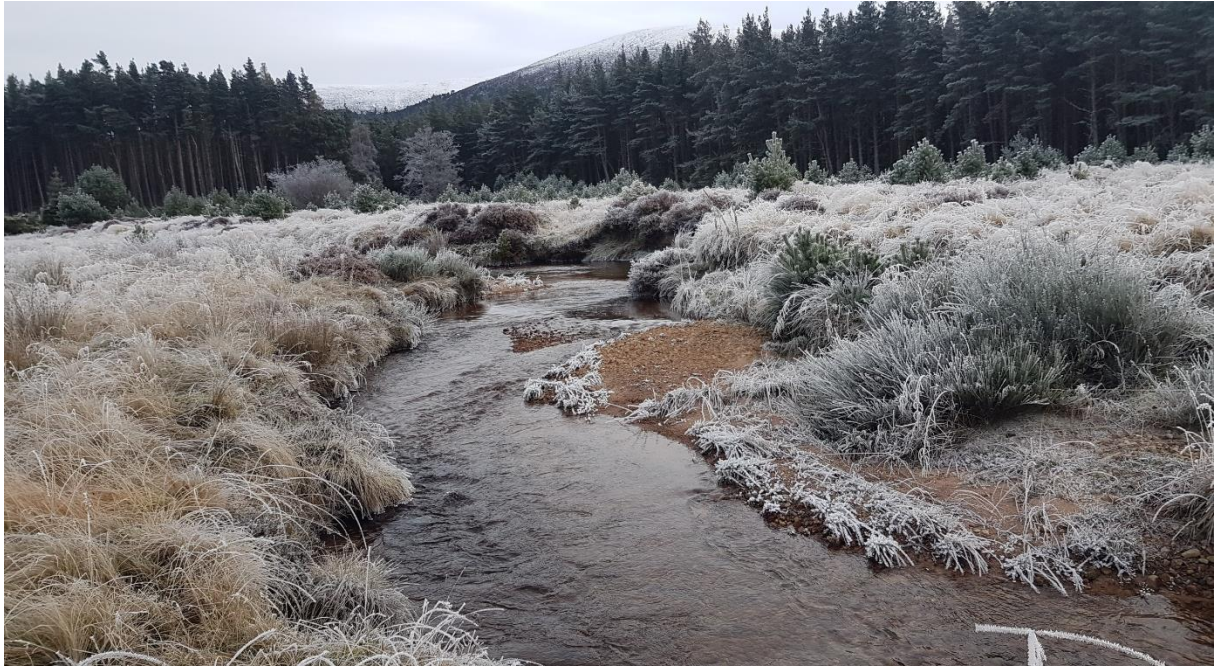
Photo 2-3: Meander at the boundary of the upstream and central reach with sediment deposition

The upper part of the upstream section of the study reach was noted to include some active meandering, with some sediment deposition on the inside of the meander bend, as shown in Photo 2-3. This sinuosity reduces downstream, with the downstream reach generally straight, with only little sediment deposition, as shown in Photo 2-4. Due to its morphology, this lower reach is effectively a transport reach, with limited opportunity for sediment deposition.

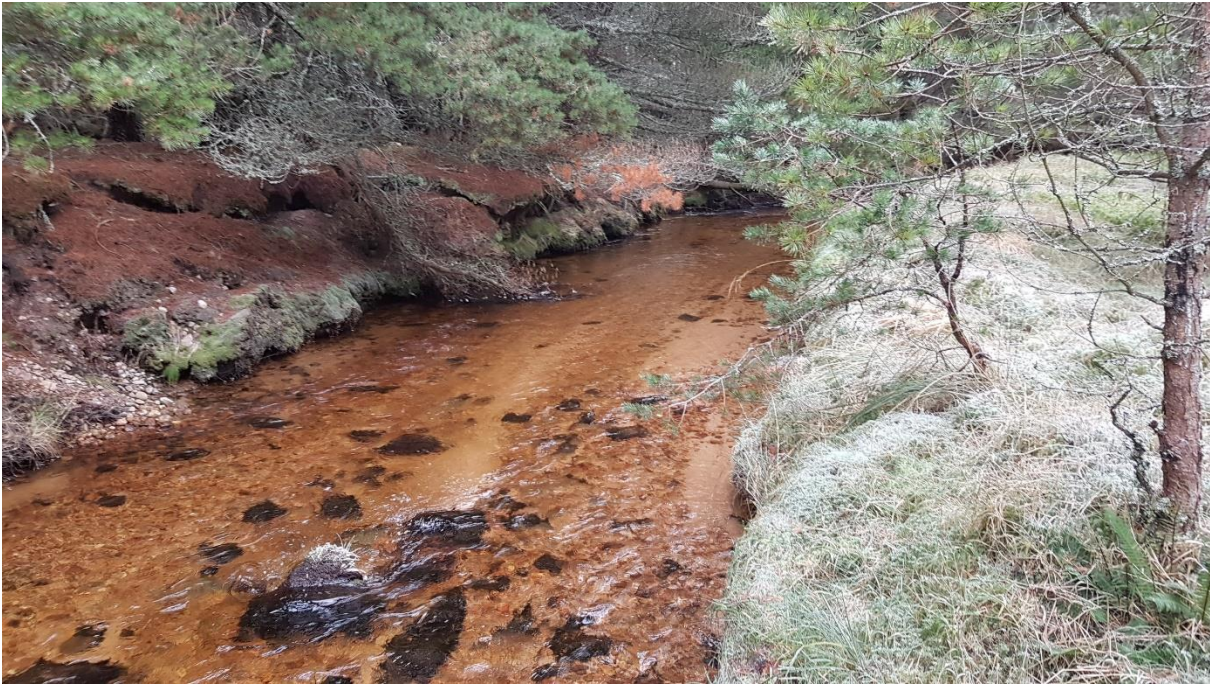
Photo 2-5: Bank composed of gravels and cobbles partially stabilised by vegetation

The bed substrate is composed of coarse sands with some gravels, pebbles and some limited larger cobbles. In the upstream section of the study reach the watercourse appears to have banks formed of gravels and larger cobbles. The presence of forestry in this area appears to act to stabilise the channel banks, preventing the watercourse from eroding and transporting this material (Photo 2-5).

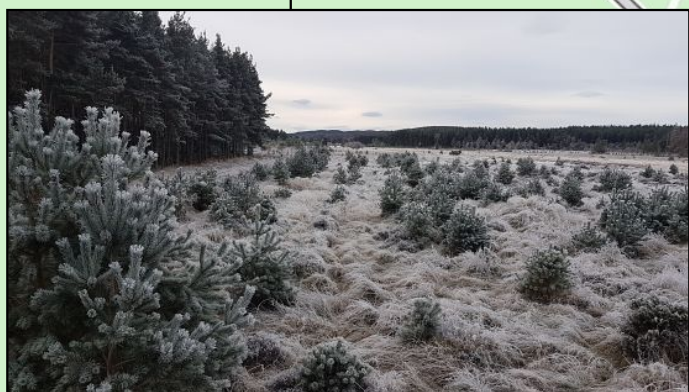
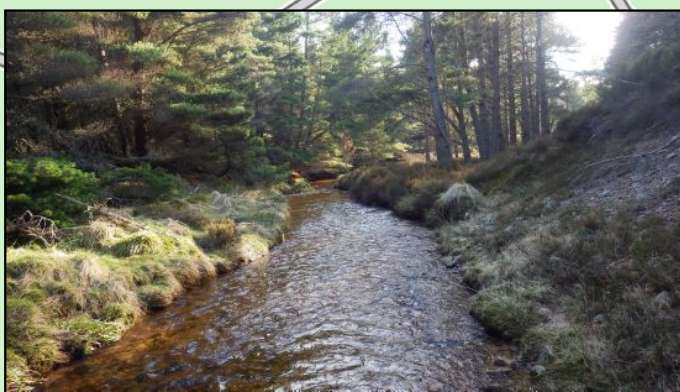
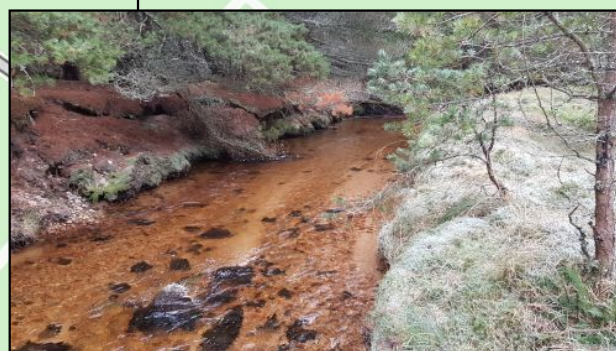
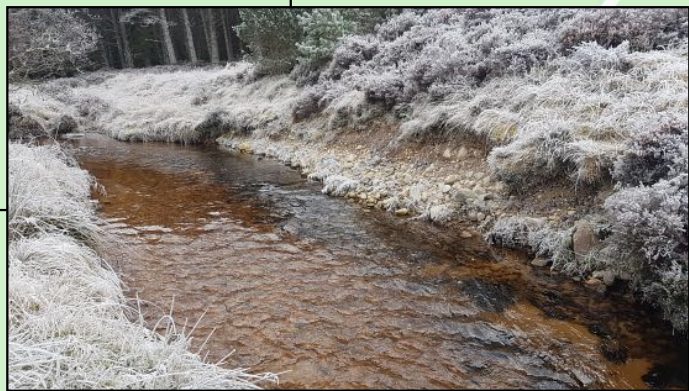
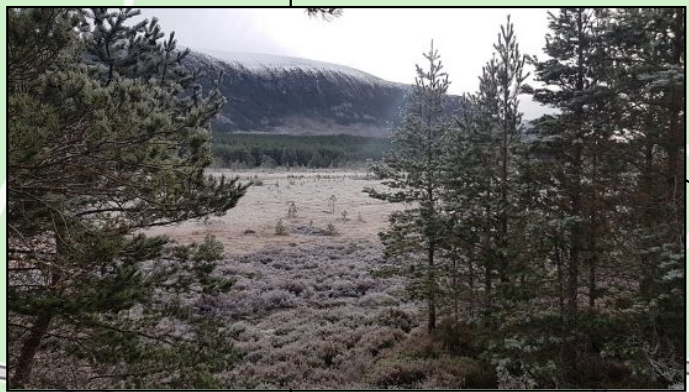
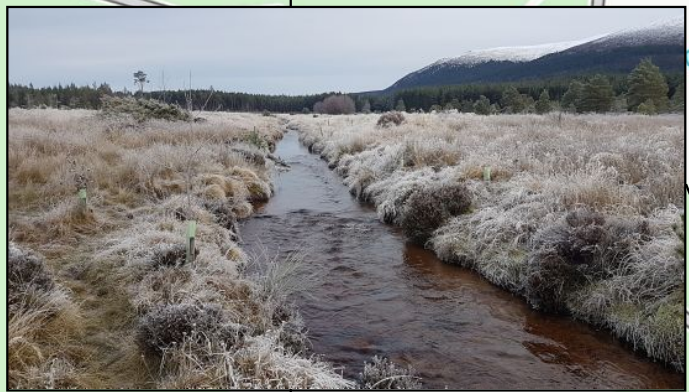
Drawing No. 673614-QGIS001	Revision REV02	Date 21 MAY 2021
Drawn GPL	Checked MN	Approved KMD

Title
Photos & Locations (2019 & 2021)

A selection of relevant photos and their locations are provided in Drawing 673614-QGIS001, Appendix A.

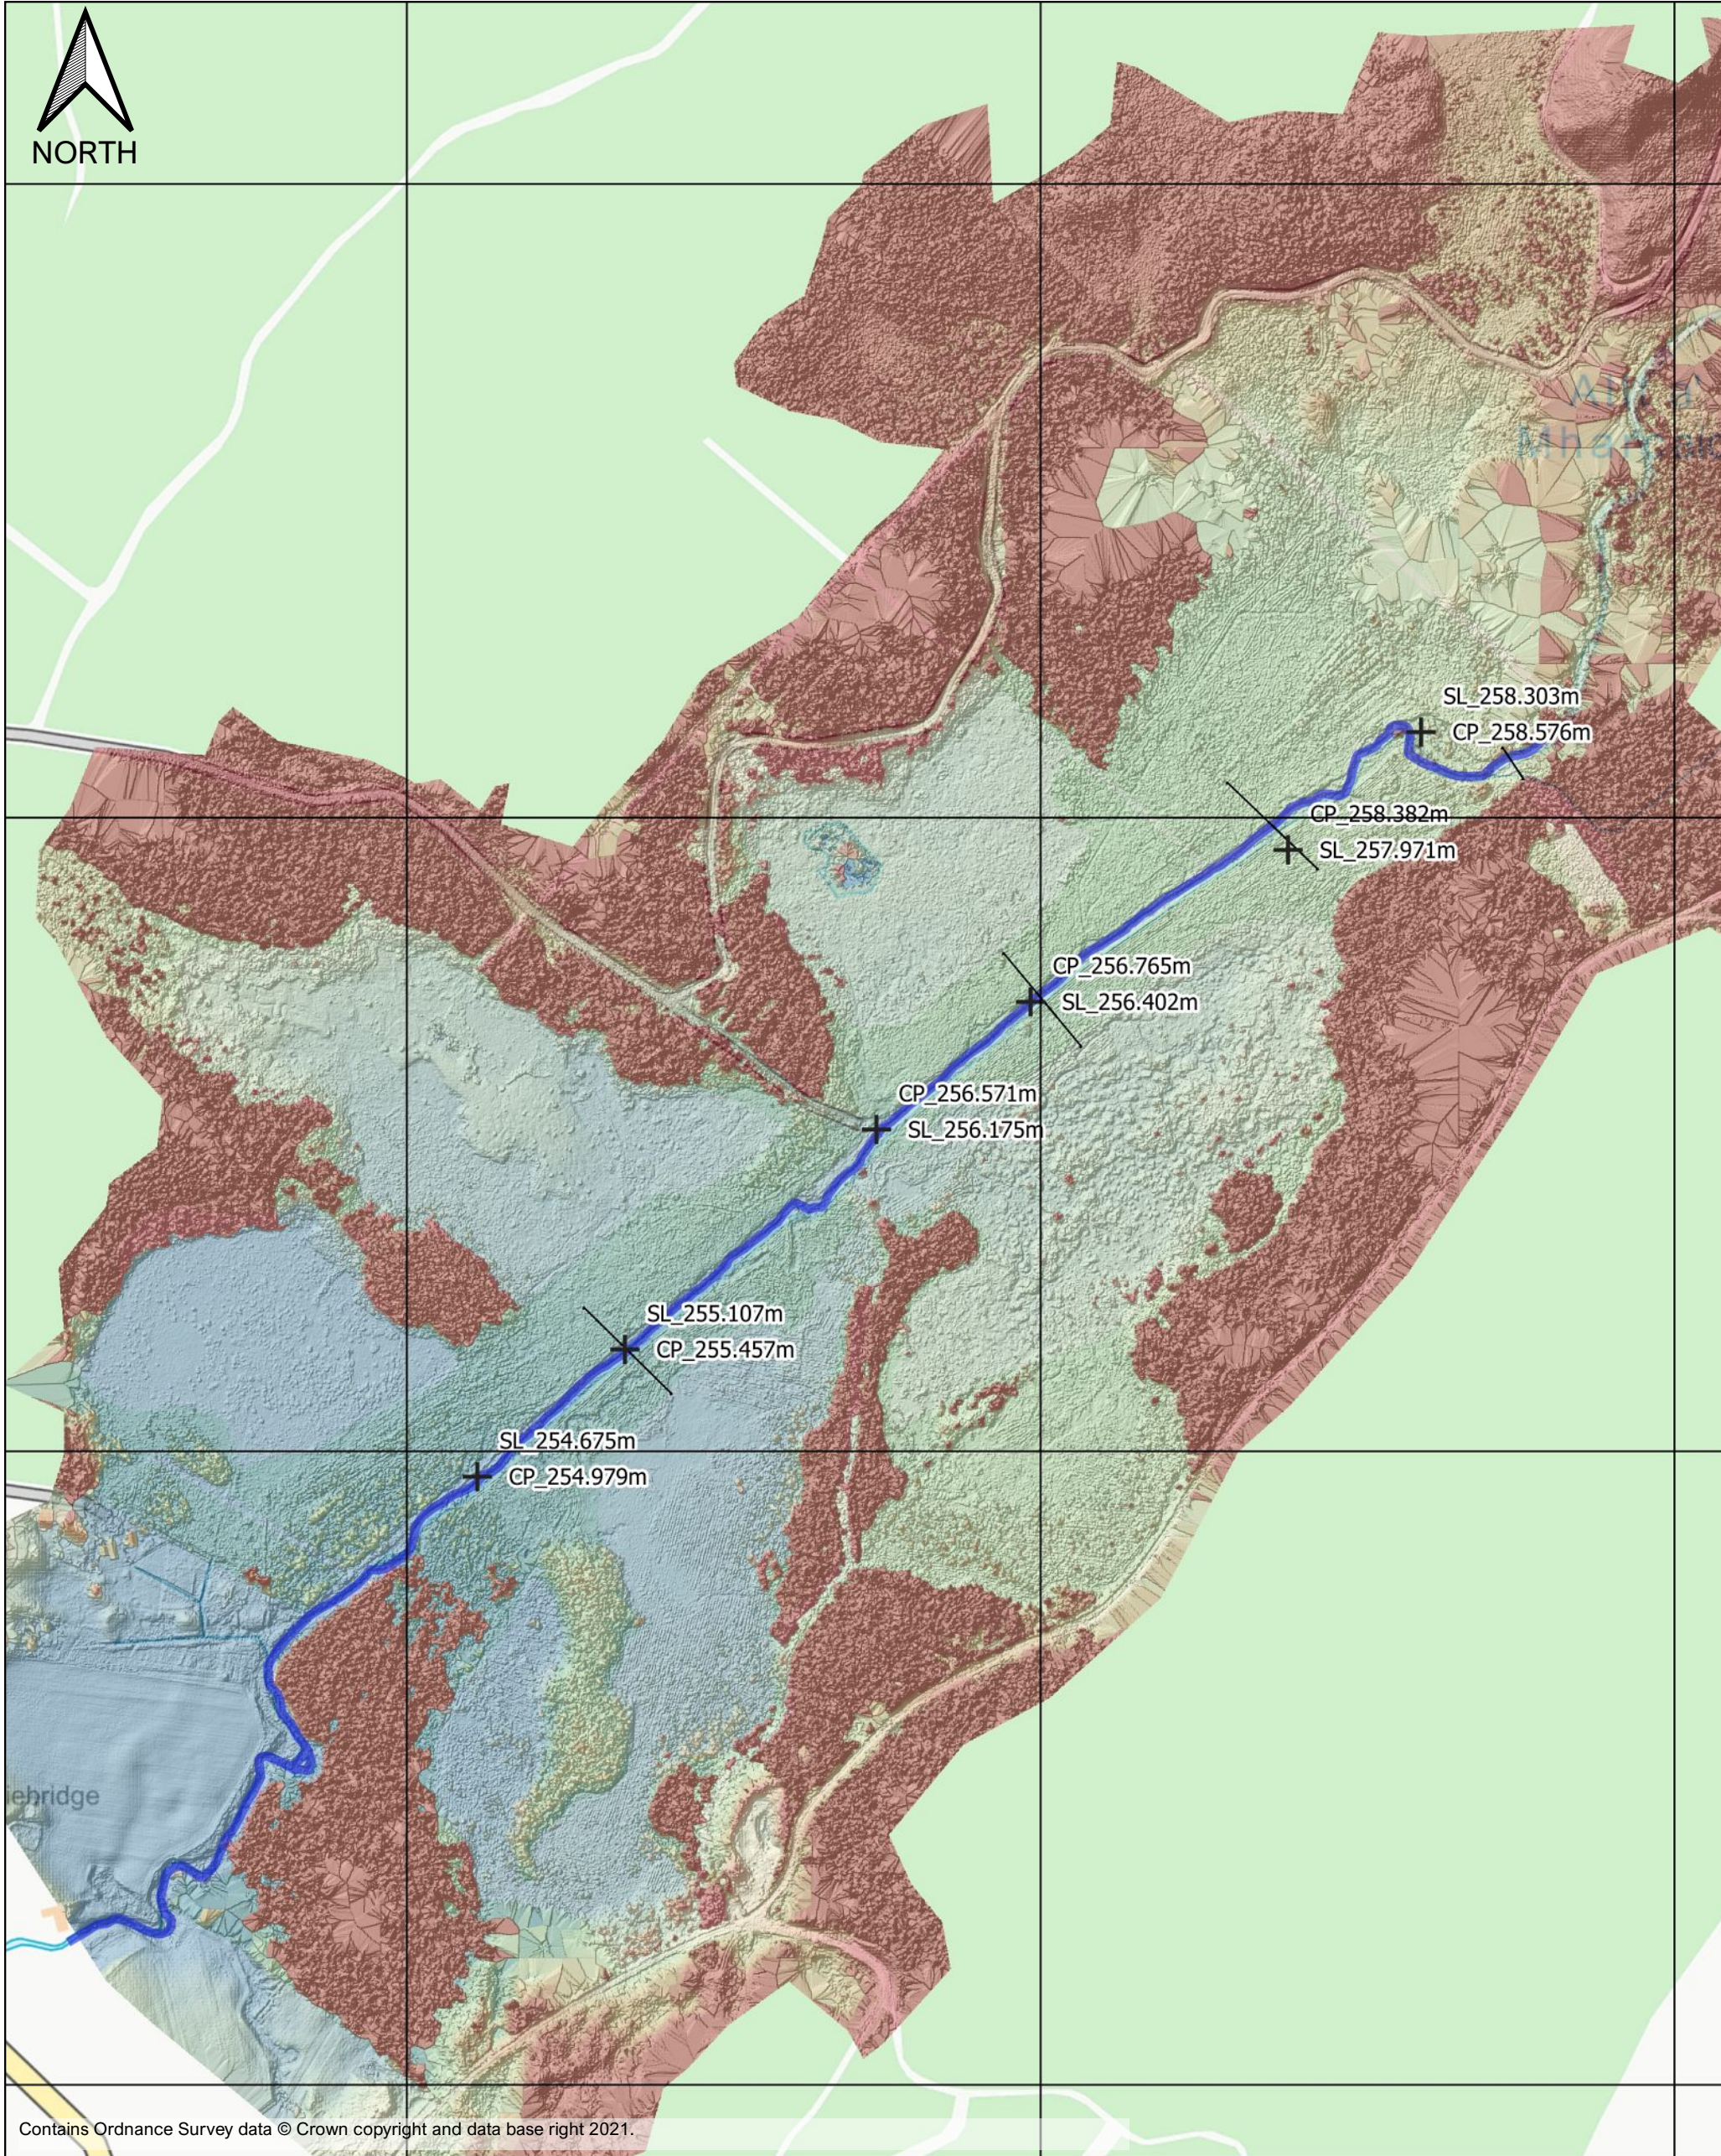
Drawing No. 673614-QGIS003	Revision REV02	Date 27 MAY 2021
Drawn GPL	Checked MN	Approved KMD

UAV DSM (2021) m AOD

— Surveyed Cross-section Locations

Title
UAV Digital Surface Model (2021 UAV) & Topographical survey information

An overview of the DSM and aerial photography are presented in Drawings 673614-QGIS002 & 673614-QGIS003, Appendix A. This DSM data was supplemented by OS T5 terrain data for the surrounding areas. The OS T5 terrain data with contours is provided in Drawing 673614-QGIS004, Appendix A.
